Report No. CG-D-40-77

RECREATIONAL BOAT SAFETY
COLLISION RESEARCH:
COLLISION ACCIDENT INVESTIGATIONS
JULY 1976 - DEC 1976

JANUARY 1977

FINAL REPORT

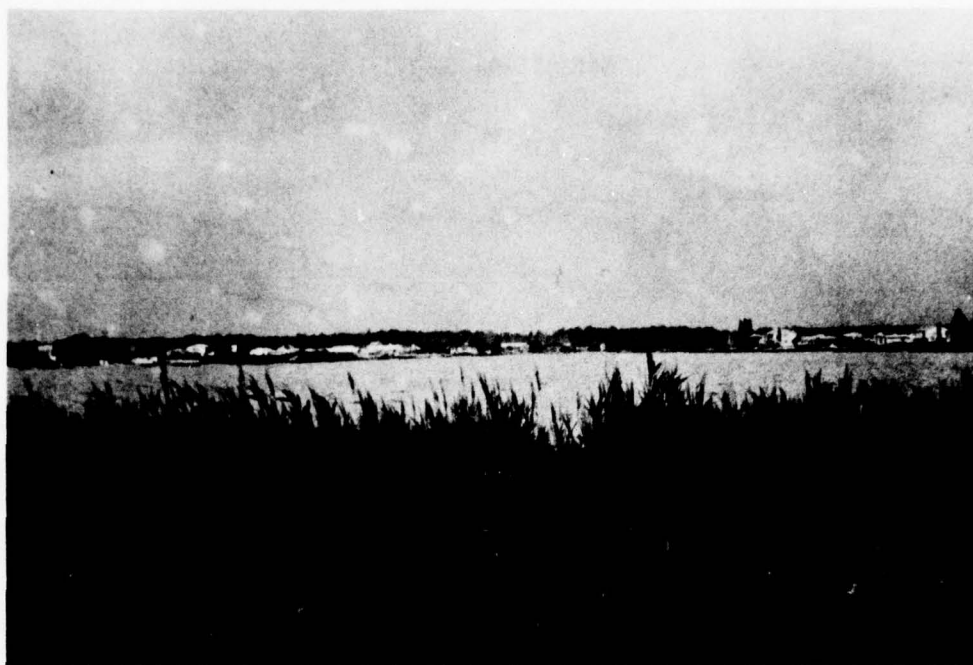
The runabout was on plane and bow high at impact. It appears that the initial contact was a glancing blow, which continued the starboard swing of the runabout's stern, which had been started by the operator's avoidance maneuver. The difference in the amounts of damage to the two boats was due to differences in their underwater surface areas, their weights, speeds, types of construction, and hull thicknesses.

FIGURE 3. COLLISION AREA

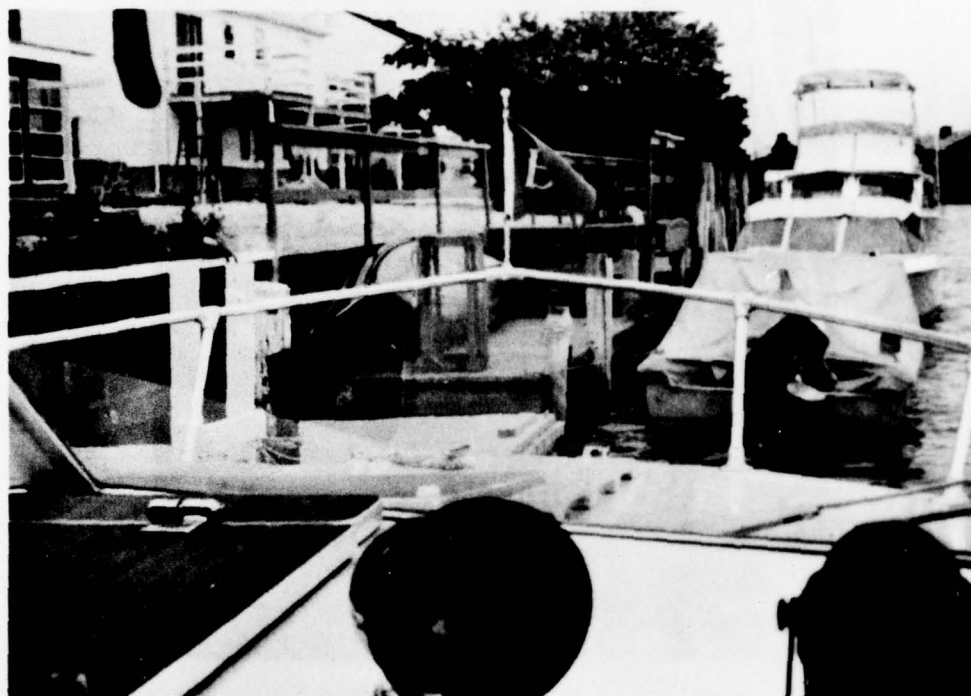
FIGURE 5. 21' (6.5 M) CRUISER. VIEW FROM HELM

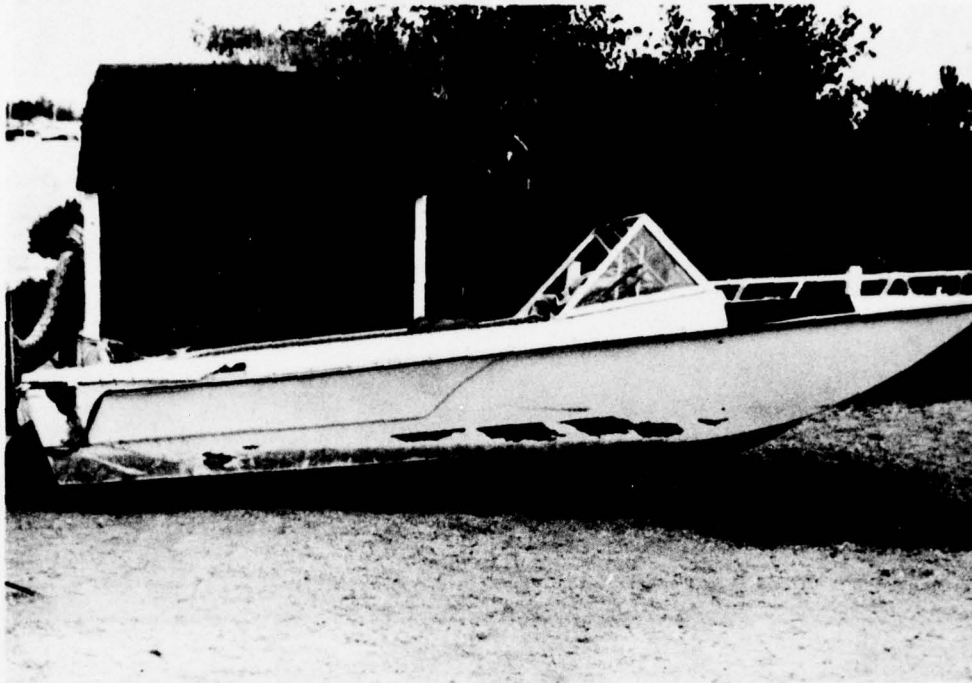
FIGURE 9. 14' (4.3 M) RUNABOUT

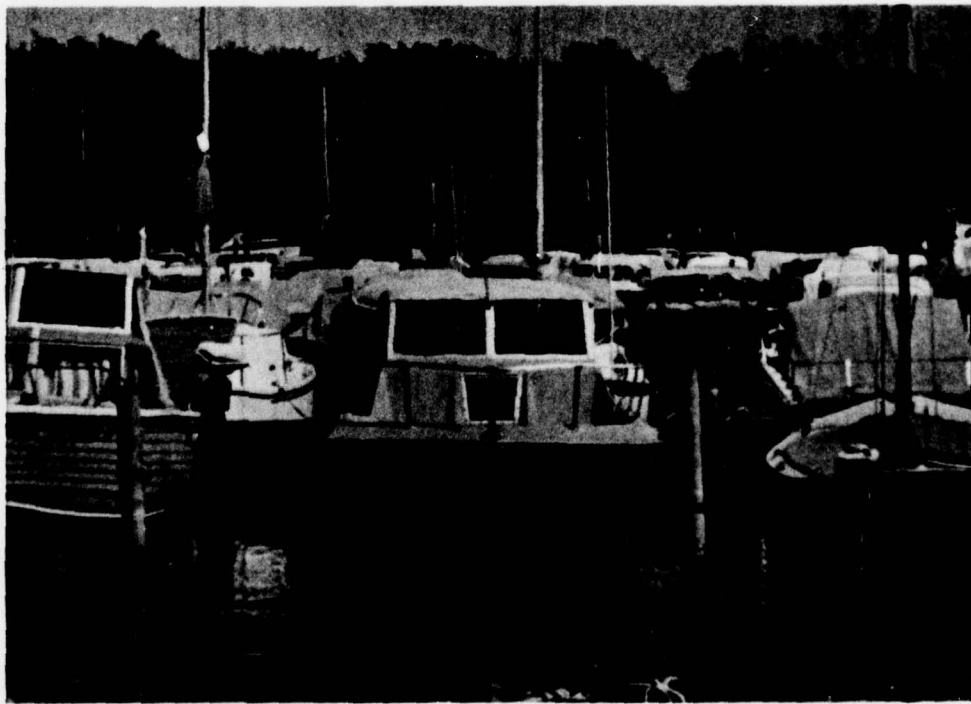
FIGURE 5. BOW OF 21 FT (6.4 M) CABIN BOAT

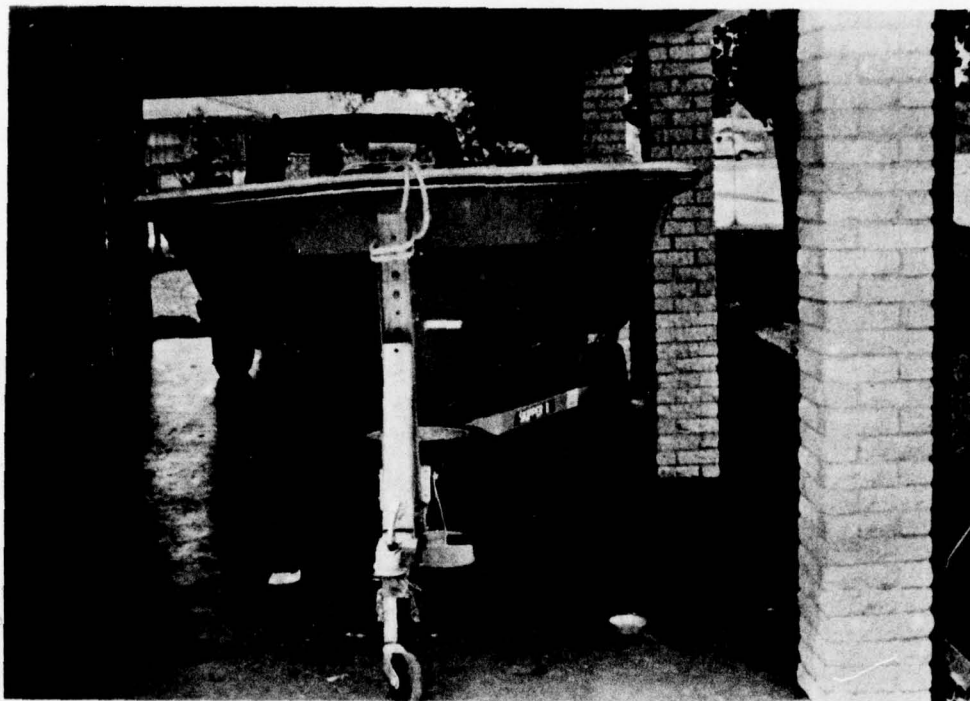
The hull design and load distribution in Boat #1 would have made it run in a near level attitude at any speed over 20-25 mph (32.2-40.3 kph). Damage to the bow bump rail shows that the boat was in a near level attitude on impact, which indicates that the boat was traveling at a high speed. No marks could be found on the port side of Boat #2; therefore, Boat #1 went airborne high enough to clear the port side. It is believed that the boat speed had to be near maximum (approximately 40 mph (64.4 kph)) to have sufficient momentum to clear the port side of Boat #2 after impact with the starboard side.

FIGURE 6. BOW OF BOAT #1

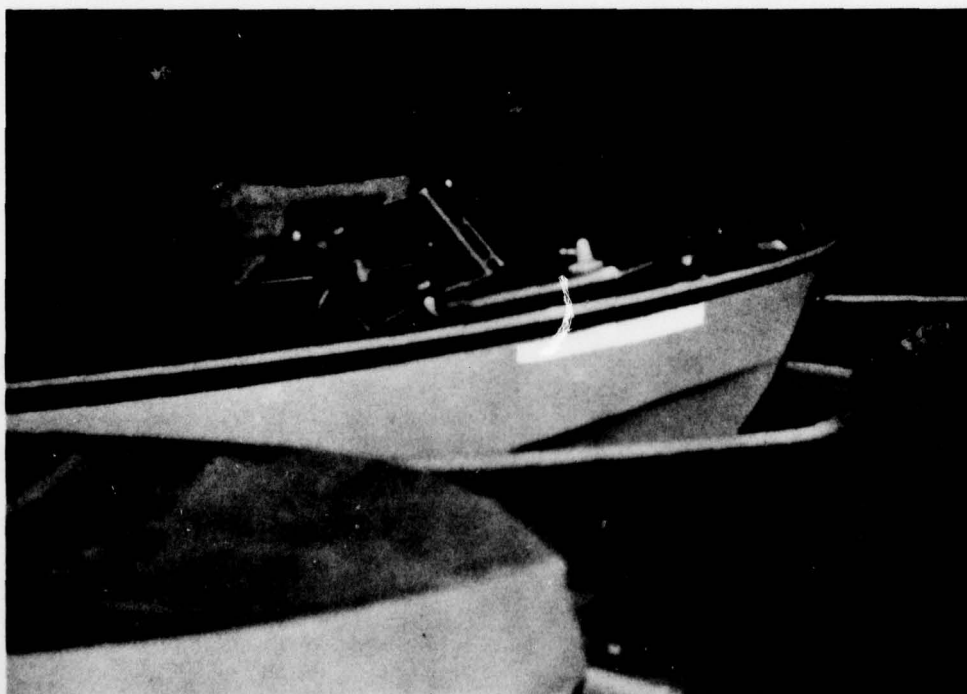
The hittor's boat was dropping off plane and was probably traveling at hump speed when it struck the skier. If it had been going slower, she probably would have been pushed aside and could have escaped unhurt.

FIGURE 2. HITTOR'S BOAT

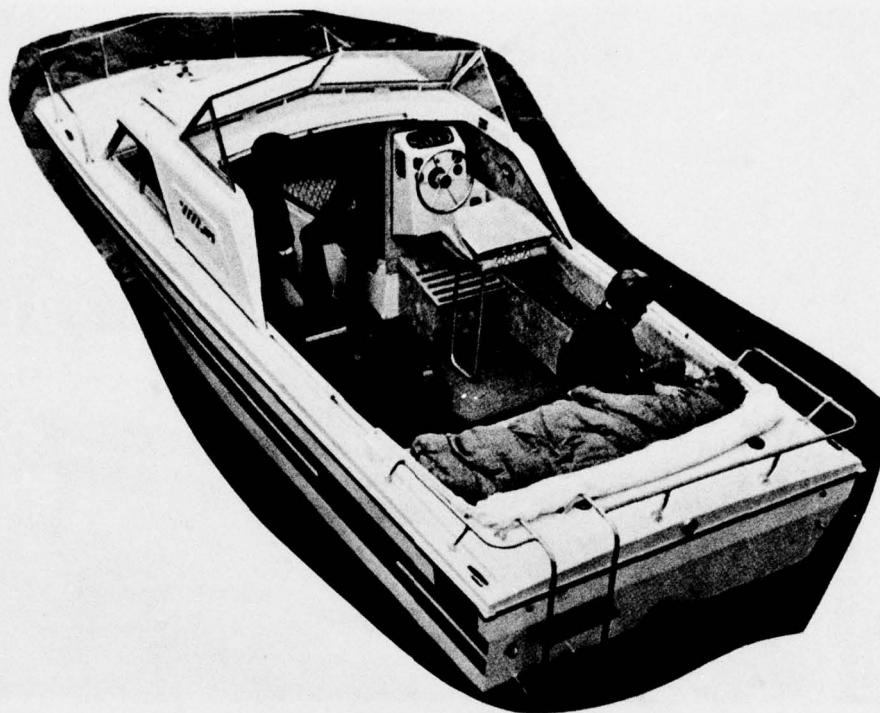
FIGURE 11. BROCHURE PICTURE OF MFG GYPSY 21 FOOTER

Damage to this boat was very extensive as shown in Figures 5 through 10. Figure 11 was taken from the brochure of the manufacturer (convertible top and passenger seat not shown). The boat was considered a total loss (about \$ 7,000 after salvage of engines and drives, etc.).

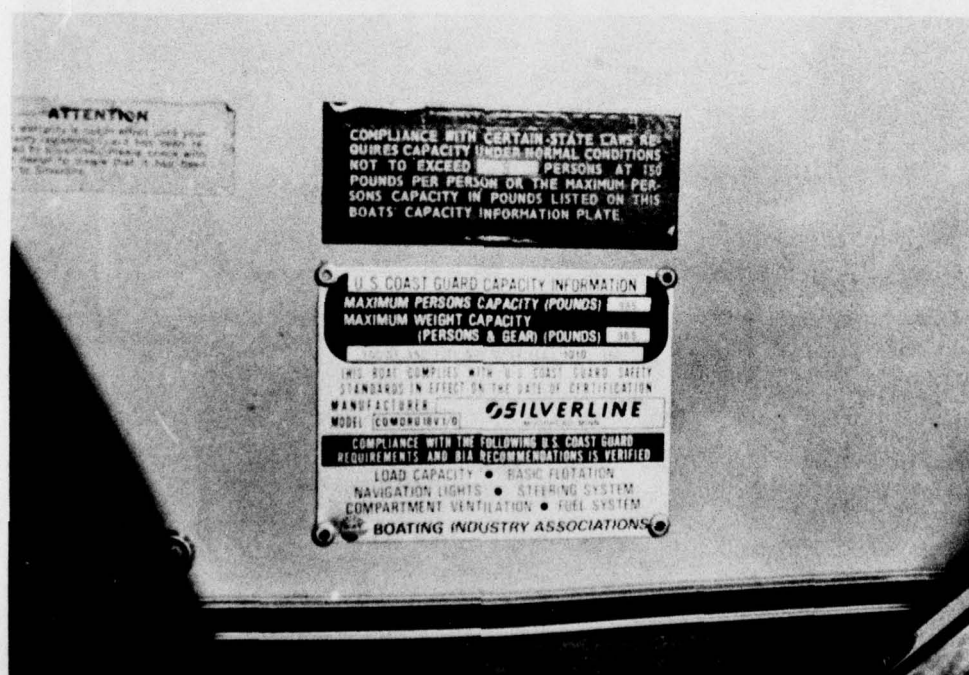
FIGURE 12. BOAT NO. 2 CAPACITY PLATE

This boat was a Silverline model Comoro 18 V. The LOA was 17 ft 7 in. (5.4 m) with a beam of 85 in. (2.2 m) at the transom and weighing approximately 2000 lb (907 kg). Maximum persons capacity was 985 lb (446.8 kg); maximum weight capacity was 985 lb (446.8 kg) (capacity label, Figure 12). The boat was powered by a 165 hp Mercruiser I/O. Photographs of the boat are shown in Figures 13 through 18. According to the HIN, the boat was built in Model Year 1974 (probably September or November — the letter designation for the month was not readable).

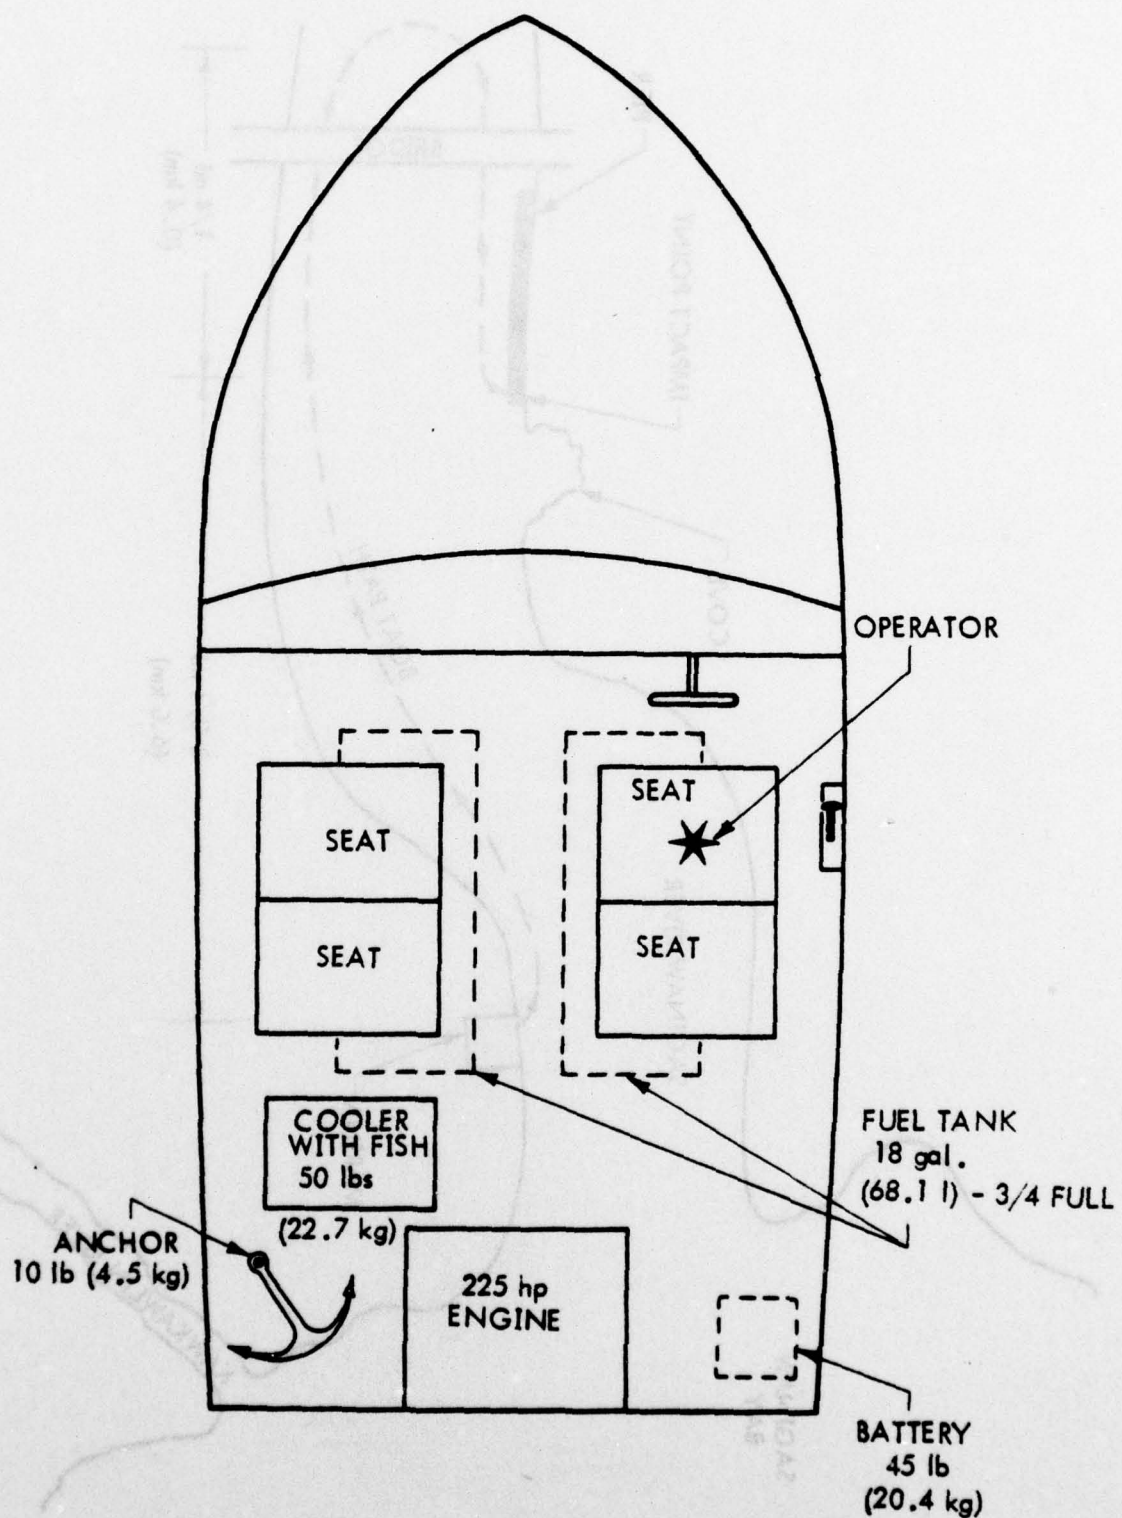
FIGURE 1. BOAT LOAD DISTRIBUTION AT TIME OF ACCIDENT

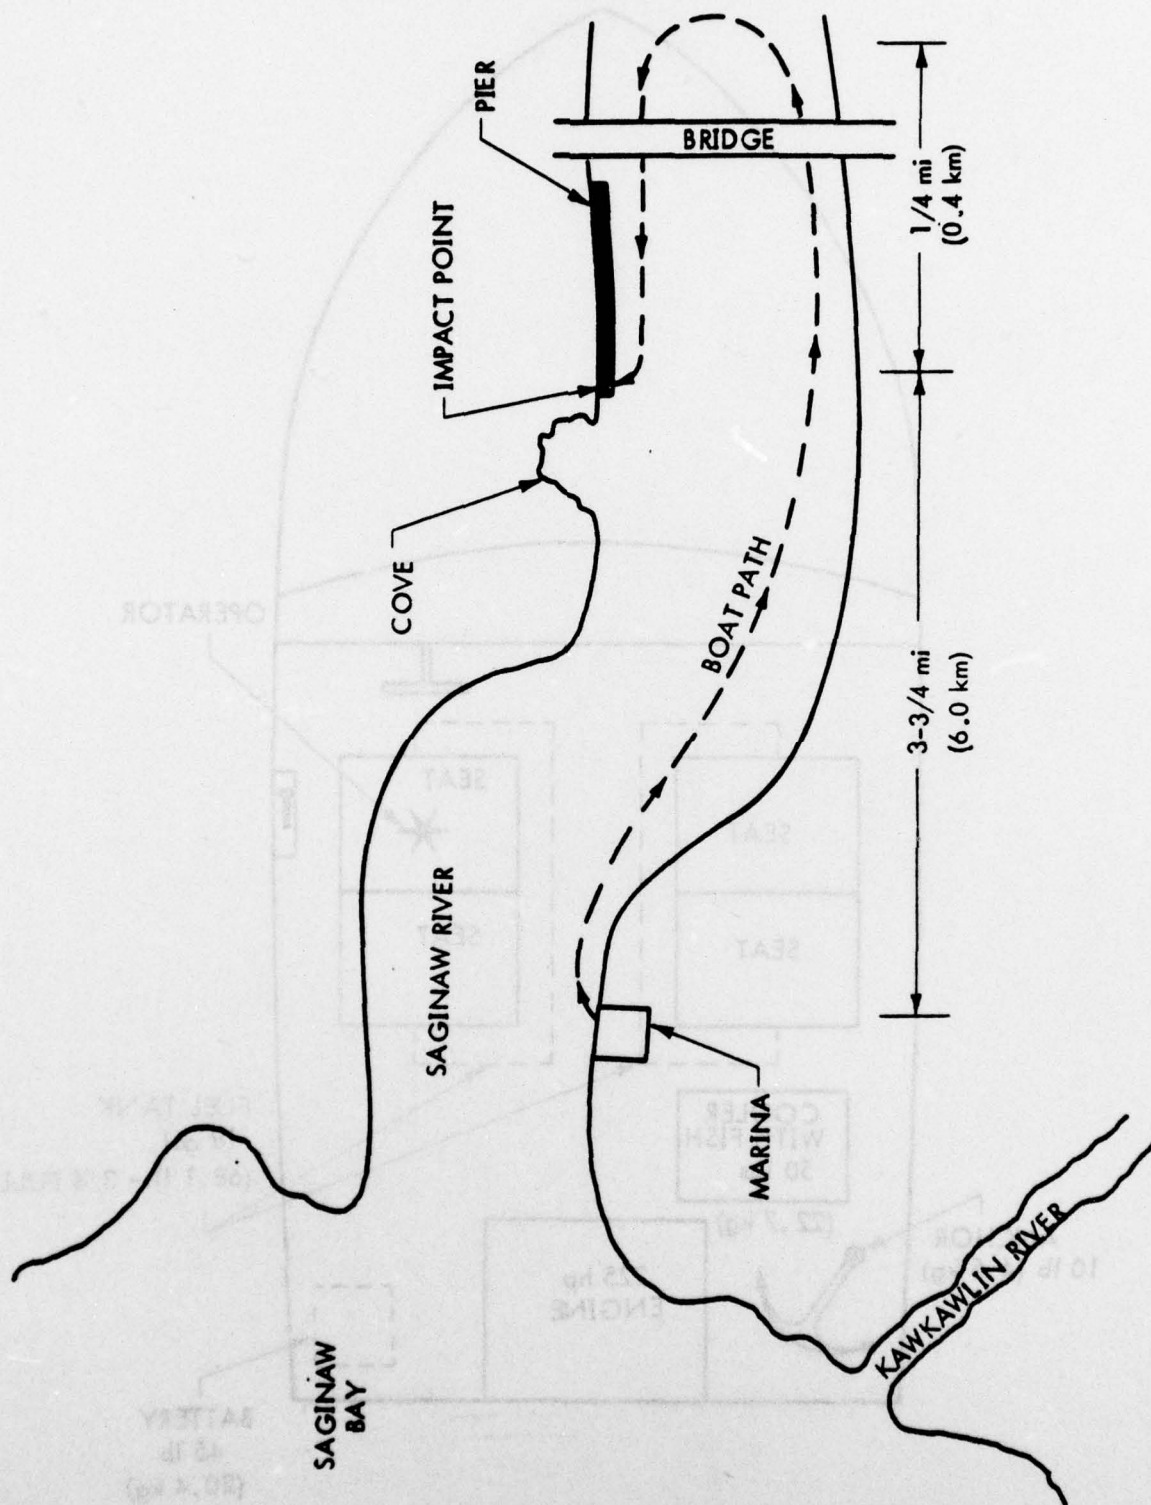
FIGURE 2. SKETCH OF ACCIDENT AREA

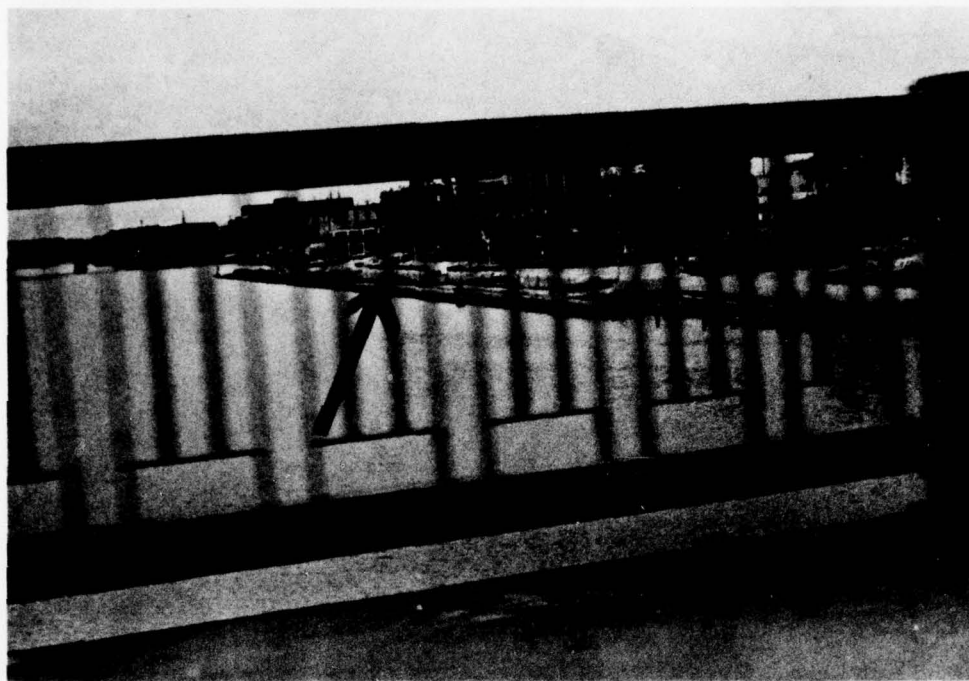
FIGURE 3. BOAT IMPACT AREA

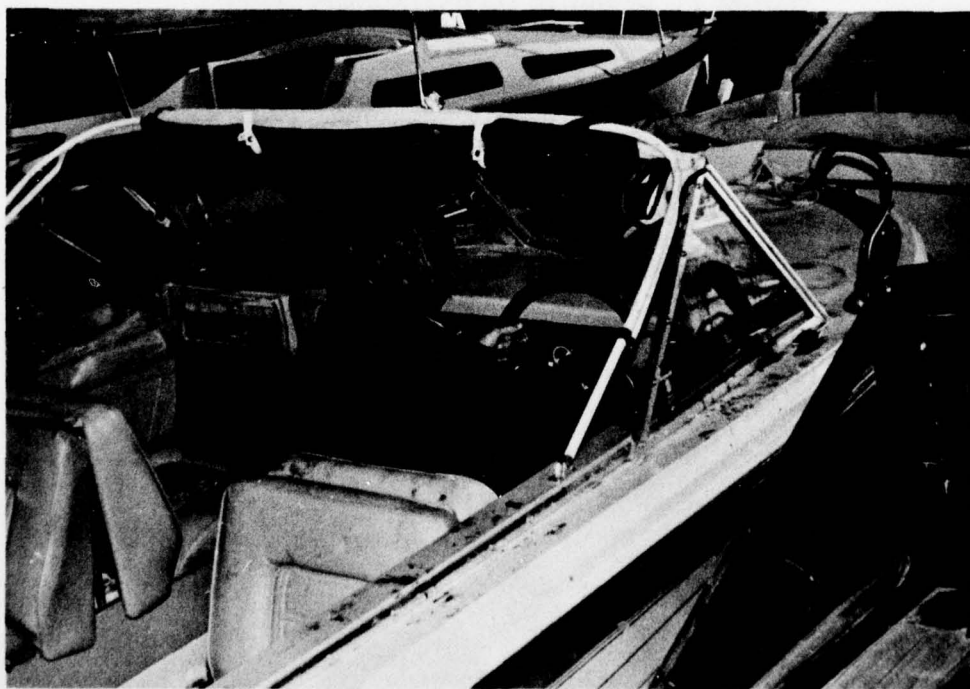
The boat was an 18 ft (5.5 m) 1972 model IMP inboard/outdrive powered by a 1972 225 hp Chevrolet engine. It was a V-hull bowrider of fiberglass construction. The capacity plate attached to the boat specified a maximum persons capacity of eight people at 150 lb (68 kg) each, a maximum weight capacity of 1600 lb (725.7 kg), and a maximum horsepower of 245. The impact resulted in major structural damage to the bow as shown in Figures 4, 5, and 6. The secondary impact of the operator's head with the instrument panel tore out the rear view mirror and broke the key off in the ignition as shown in Figure 7. The back-to-back port seats were separated at the top as shown in Figure 8. The skeg on the lower unit was broken off as shown in Figure 9. Overall boat views are shown in Figures 10-13.

FIGURE 10. OVERALL BOAT VIEW

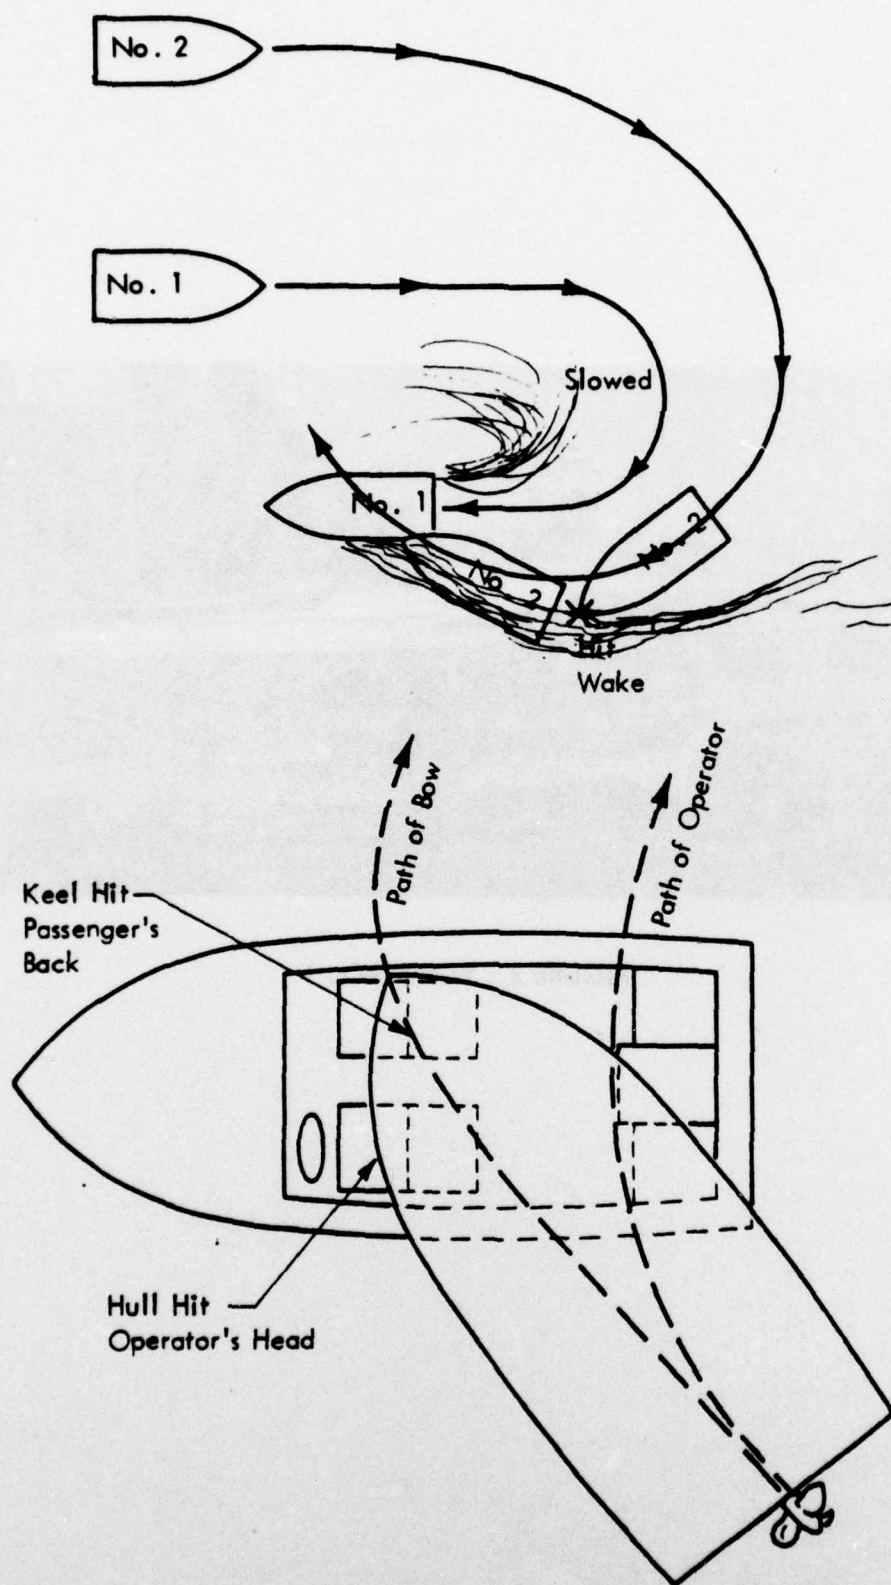
The boat continued at a bow high attitude and mounted the cockpit area of Boat No. 1. The momentum carried it completely over the other boat.

FIGURE 1. COLLISION AREA DIAGRAM

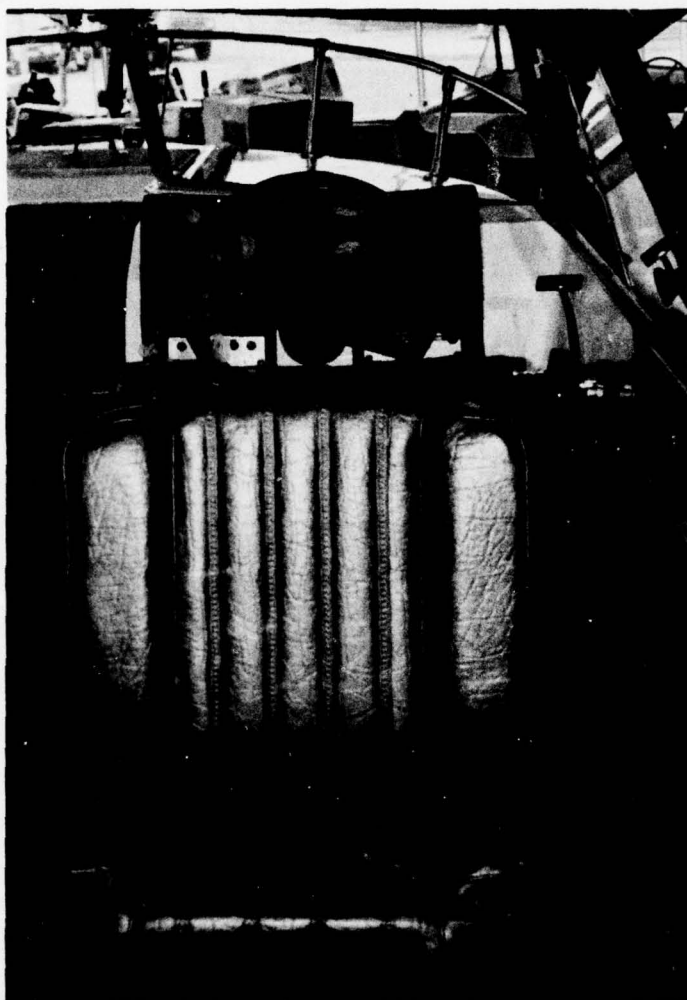
Poor forward visibility from the helm contributed to the cause. The operator couldn't see the wake forward.

FIGURE 6. CONTROL STATION - BOAT NO. 2

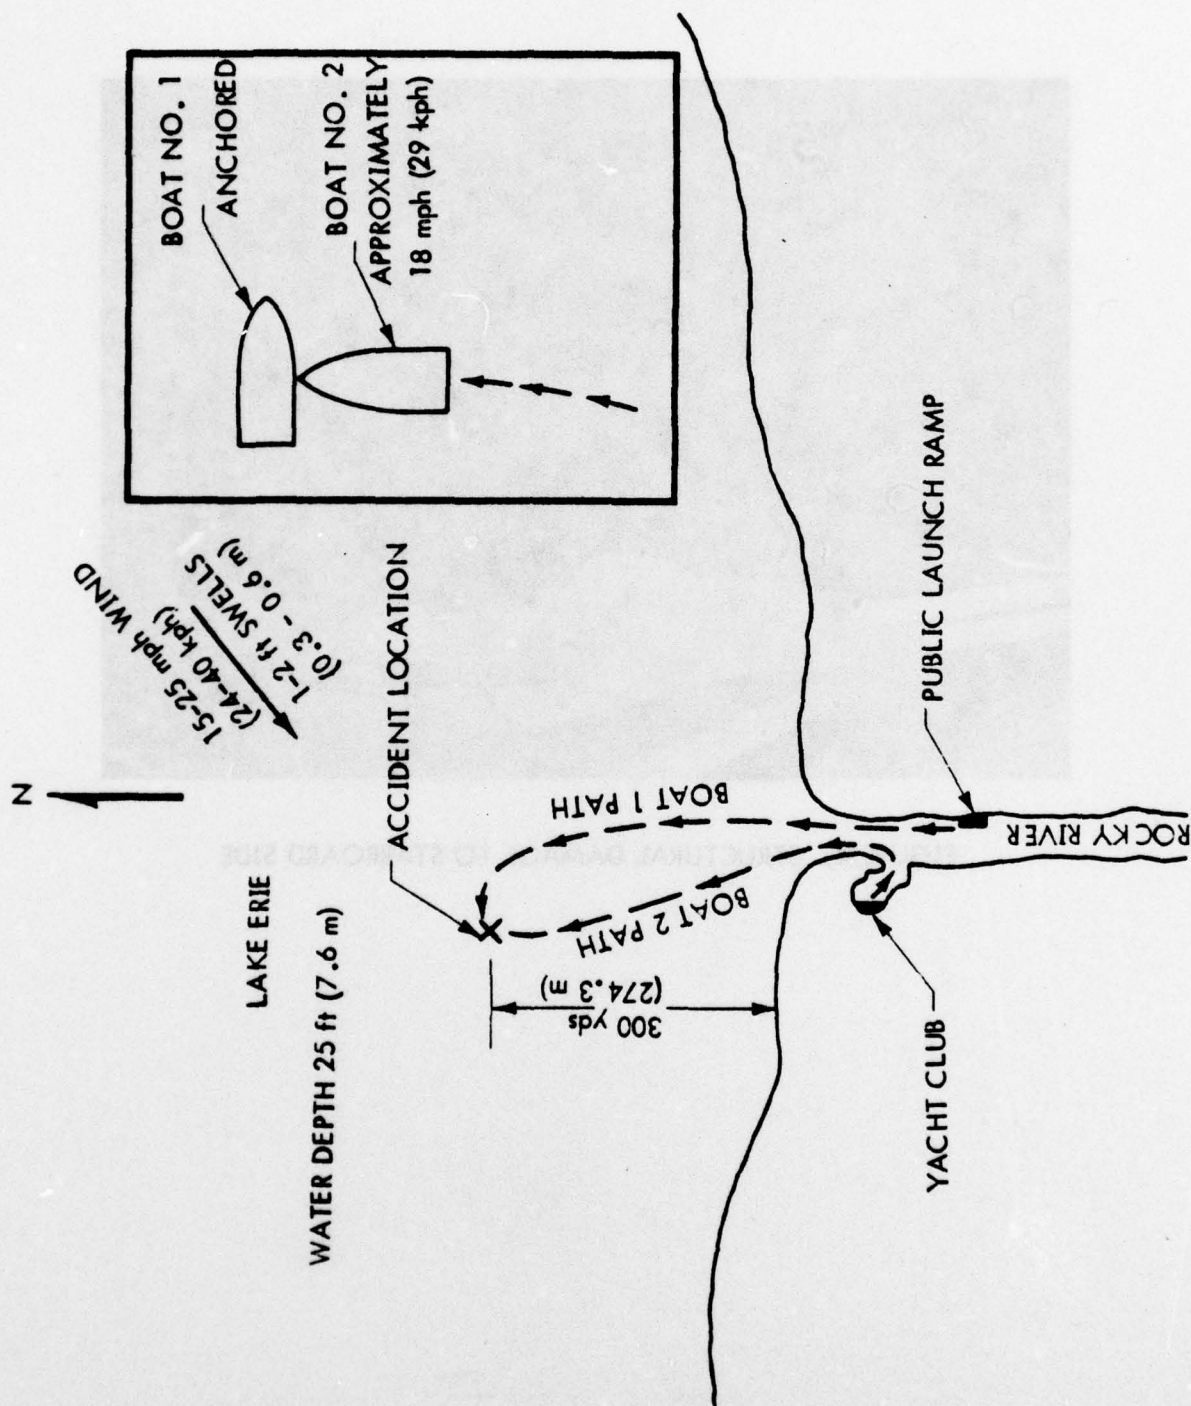
The bow of Boat No. 2 impacted the starboard side of Boat No. 1 near amidships and essentially perpendicular to the longitudinal axis. The impact ripped a large section out of the starboard side of Boat No. 1. The forward momentum of Boat No. 2 carried it across Boat No. 1 and into the water on the port side. As Boat No. 2 traversed across Boat No. 1, its weight pushed No. 1 down, causing it to begin flooding immediately. The bow of Boat No. 2 raised after impact, causing it to jump over Boat No. 1 as was evident from the minimal damage to the port side of Boat No. 1. Apparently, Boat No. 1 was pushed under water or sank immediately because the occupants of Boat No. 2 did not see it within seconds after the collision. Within a short time after sinking, Boat No. 1 rolled upside down and the bow section resurfaced.

FIGURE 3. SKETCH OF ACCIDENT AREA

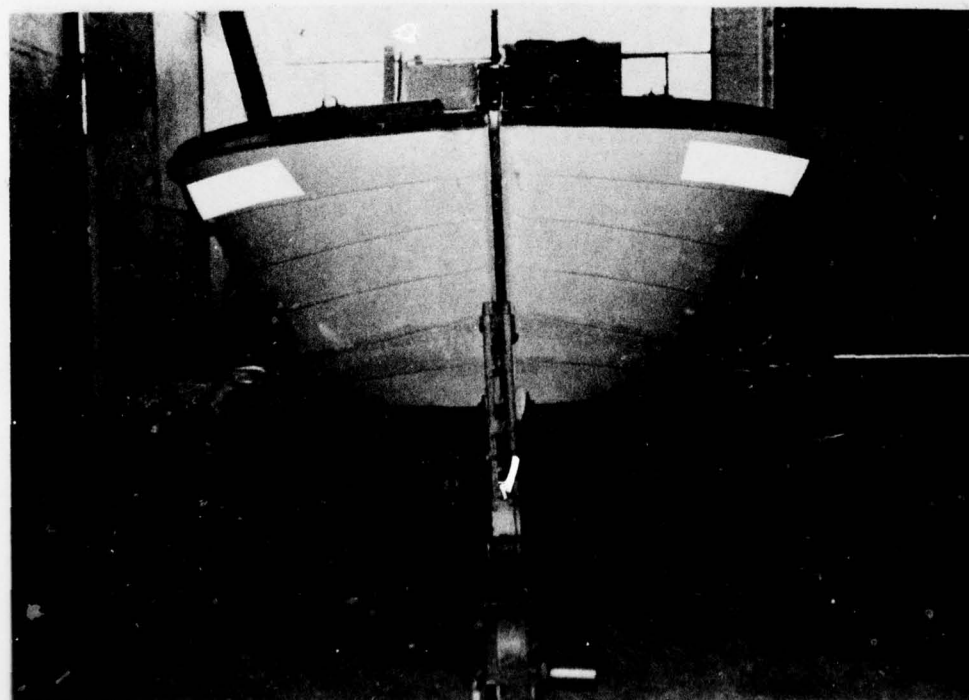
The boat was a 15-1/2 ft (4.7 m) 1962 Model Pen Yan runabout powered by a 1962 40 horsepower West Bend outboard motor. It was a semi-V closed bow of 3/4 in. (1.9 cm) wood lapstrake construction. The OBC plate attached to the boat specified a maximum weight capacity of 1305 lb (592 kg) and a maximum horsepower capacity of 60. The collision resulted in major structural damage to the starboard side as shown in Figures 4 and 5. Moderate damage to the port gunwale is shown in Figure 6. The aft facing seat was torn loose from the deck on impact. Prop marks on the forward facing seat are shown in Figure 7. Bow view is shown in Figure 8.

FIGURE 8. BOW VIEW

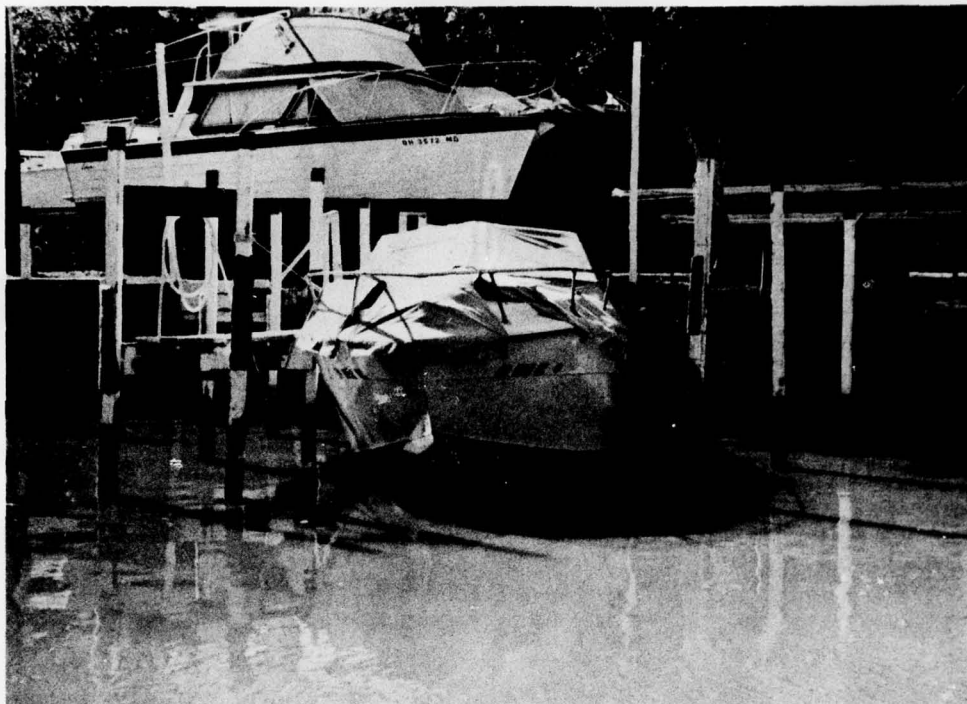
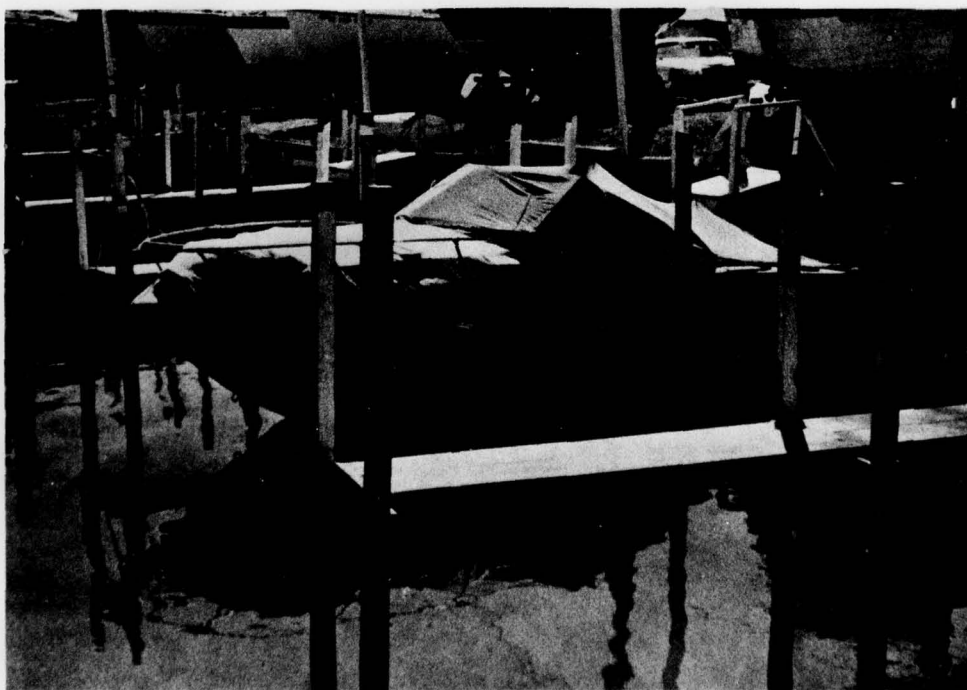
The boat was a 24 ft (7.3 m) 1972 Model Searay I/O cabin cruiser powered by two 1972 model 165 horsepower Mercury engines. The outdrives were Mercruisers incorporating power trim. Trim tabs were also installed on the transom. The hull was a deep-V of fiberglass construction. There was no capacity plate attached to the boat. The collision resulted in no damage to the boat above the static water line. The hull below the static water line could not be inspected, but it is assumed that only minor gelcoat damage existed. Refer to Figures 9 and 10 for overall boat views.

FIGURE 9. OVERALL BOAT VIEW

FIGURE 10. OVERALL BOAT VIEW

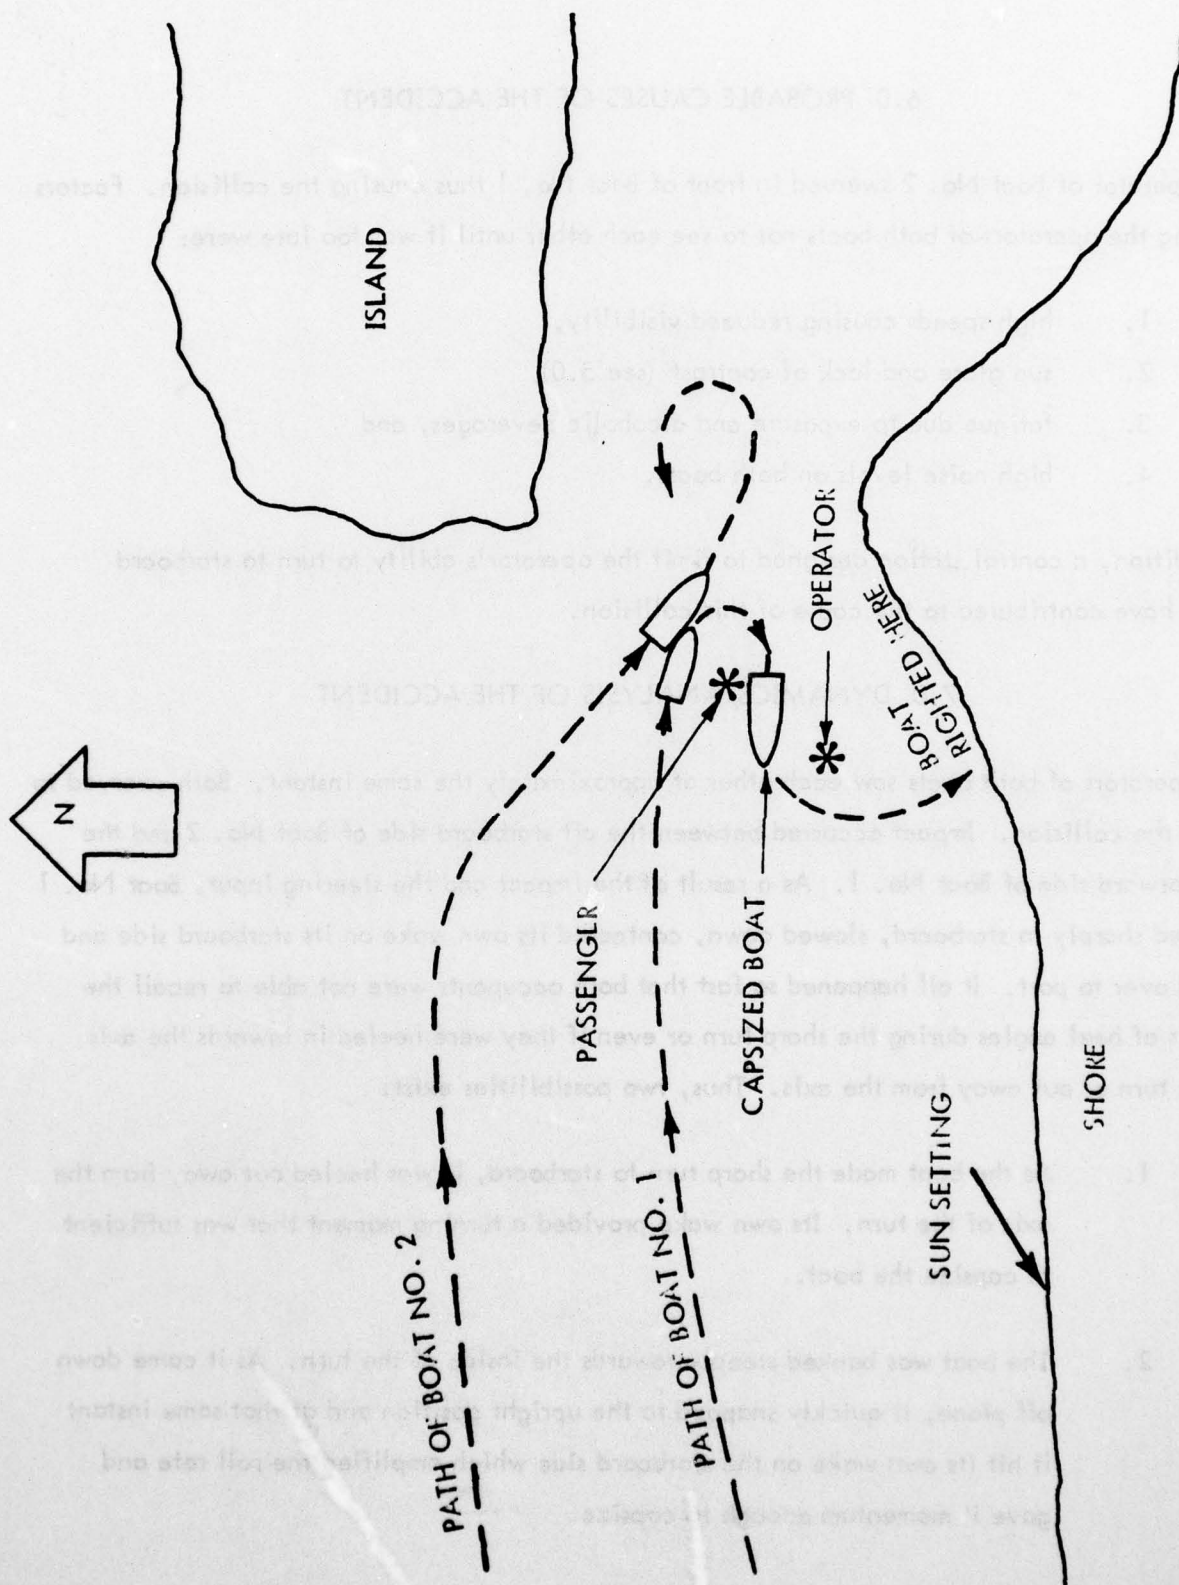
The operators of both boats saw each other at approximately the same instant. Both swerved to avoid the collision. Impact occurred between the aft starboard side of Boat No. 2 and the port forward side of Boat No. 1. As a result of the impact and the steering input, Boat No. 1 swerved sharply to starboard, slowed down, contacted its own wake on its starboard side and rolled over to port. It all happened so fast that both occupants were not able to recall the details of heel angles during the sharp turn or even if they were heeled in towards the axis of the turn or out away from the axis. Thus, two possibilities exist:

FIGURE 1. COLLISION AREA DIAGRAM
